Safety Inspection Report

Annual Inspection

Avon Dassett Play Area

17 September 2026

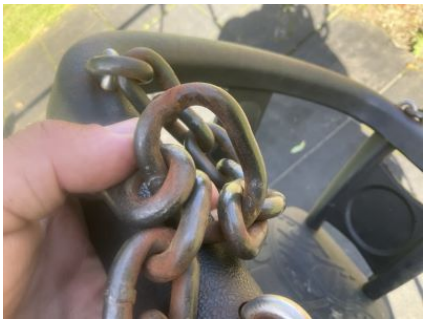
Some chain wear.

Monitor for further deterioration and replace before 40% wear.
